YOUR INSPECTION REPORT

1868 Knox Tr
Abbotsford, BC

Friday, November 8, 2013

RE: Report No. 1645, v.2
1868 Knox Tr
Abbotsford, BC

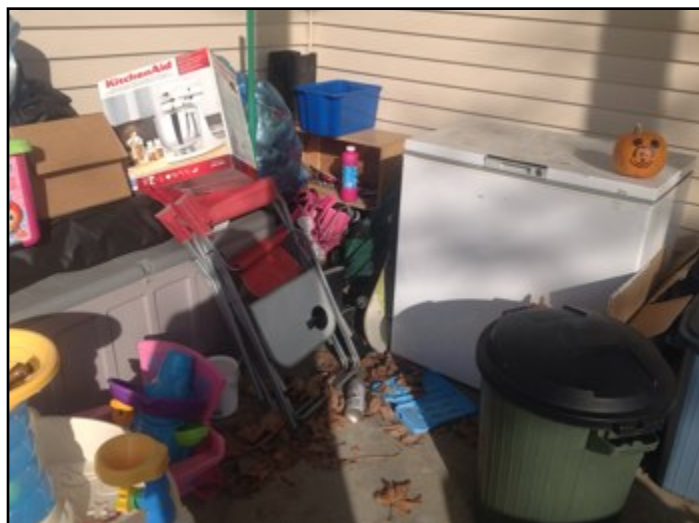
8. Storage

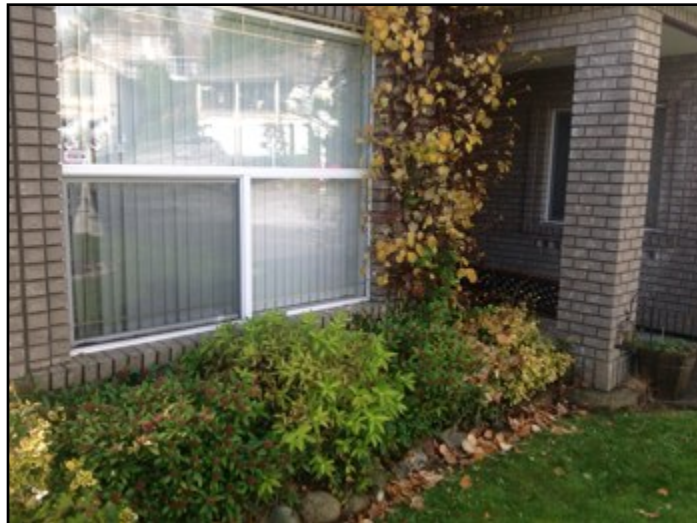
9. Vines/shrubs/trees against wall

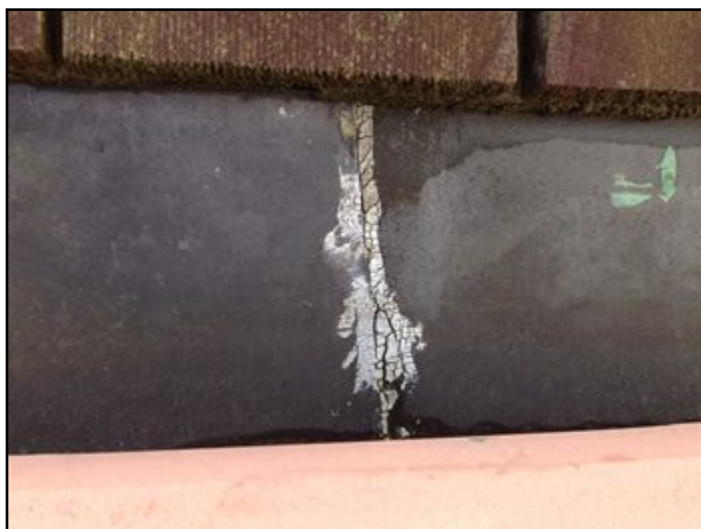
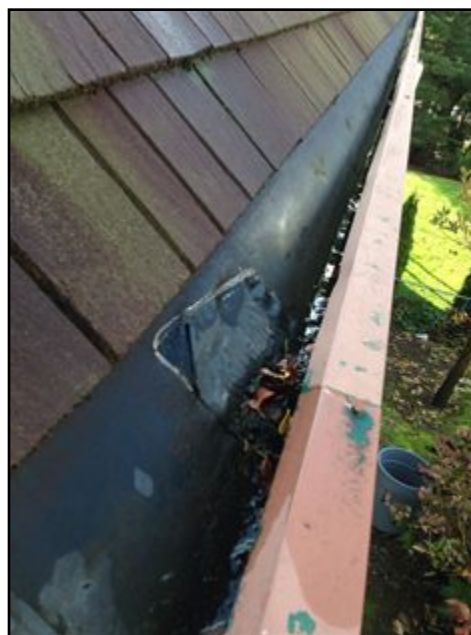
2. **Condition:** • [Leak](#)

Implication(s): Chance of water damage to contents, finishes and/or structure

10. Leak

11. Leak

Task: Service

Time: Regular maintenance

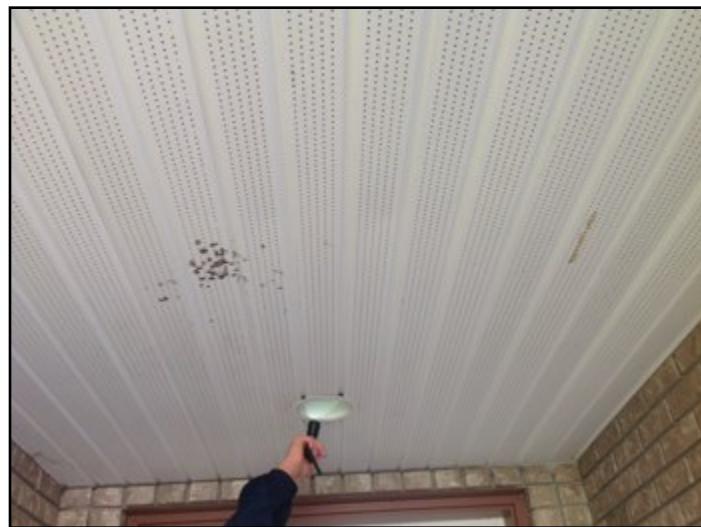
3. Condition: • [Damage](#)

Implication(s): Cosmetic defects | Chance of water damage to contents, finishes and/or structure

12. Damage

Task: Further evaluation

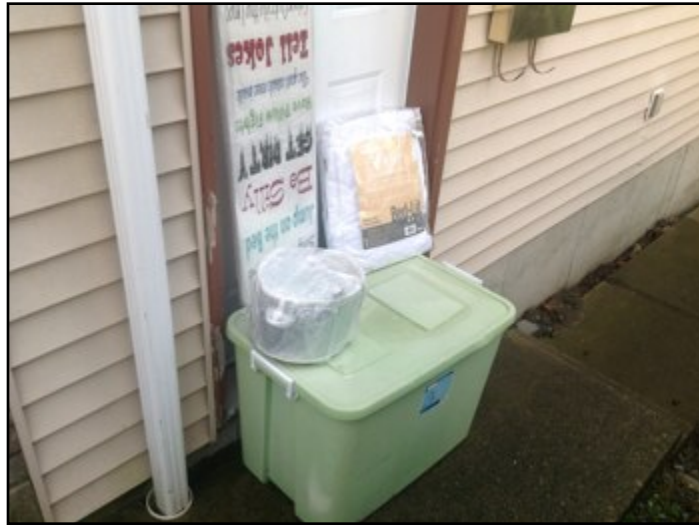
4. Condition: • Paint or stain needed

13. *Paint or stain needed*

Task: Service

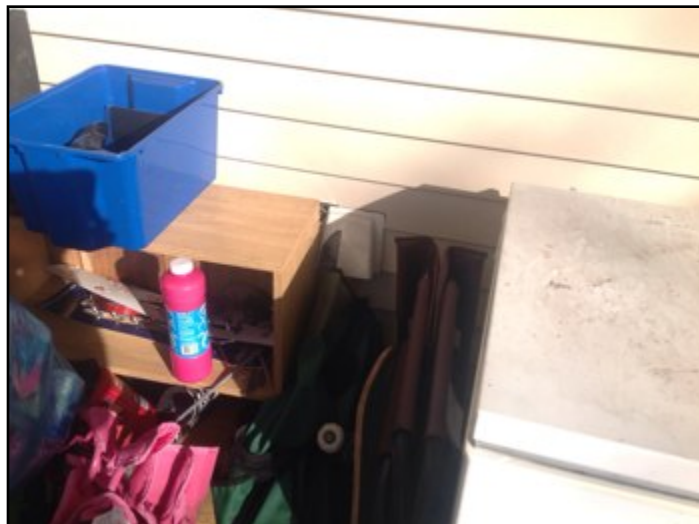
5. Condition: • [Mechanical damage](#)

Implication(s): Cosmetic defects | Chance of water damage to contents, finishes and/or structure

14. *Mechanical damage*

Task: Service

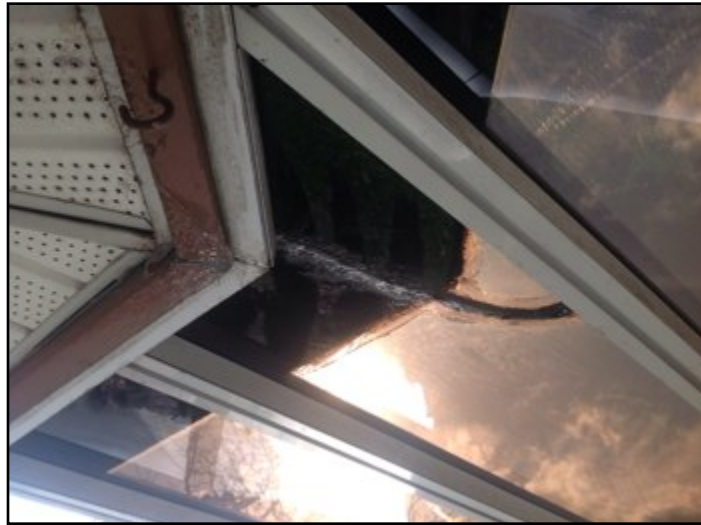
6. Condition: • [Water leaks](#)

Implication(s): Chance of water damage to contents, finishes and/or structure

15. Water leaks

Task: Service

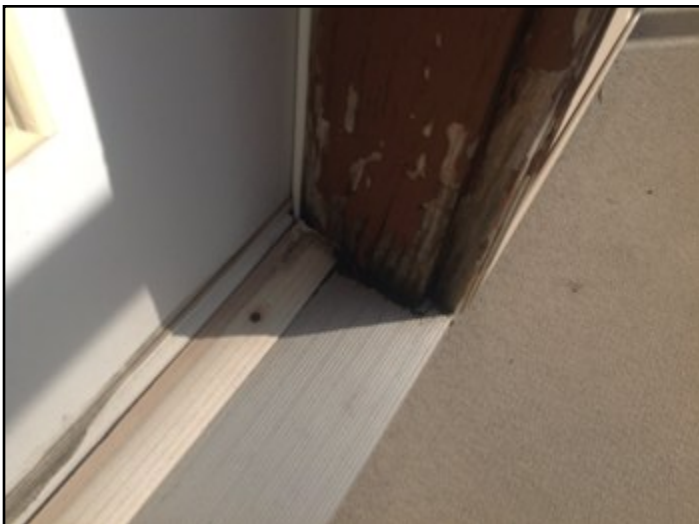
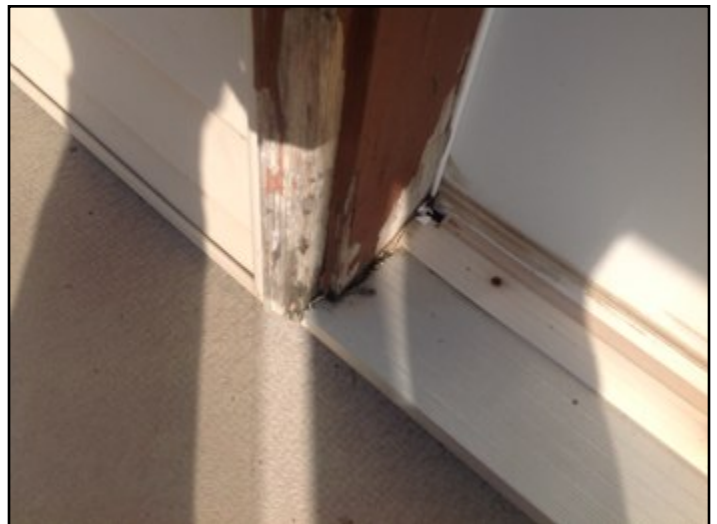
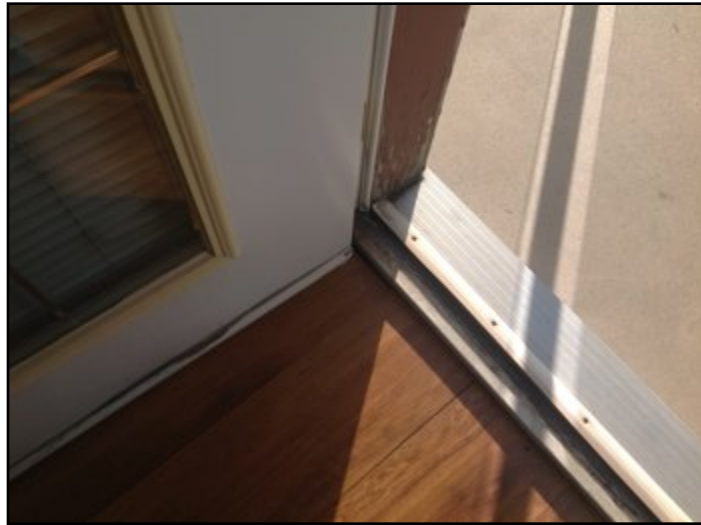
8. Condition: • [Rot](#)

Implication(s): Chance of damage to finishes and structure

16. Rot

17. Rot

18. Rot

Task: Repair

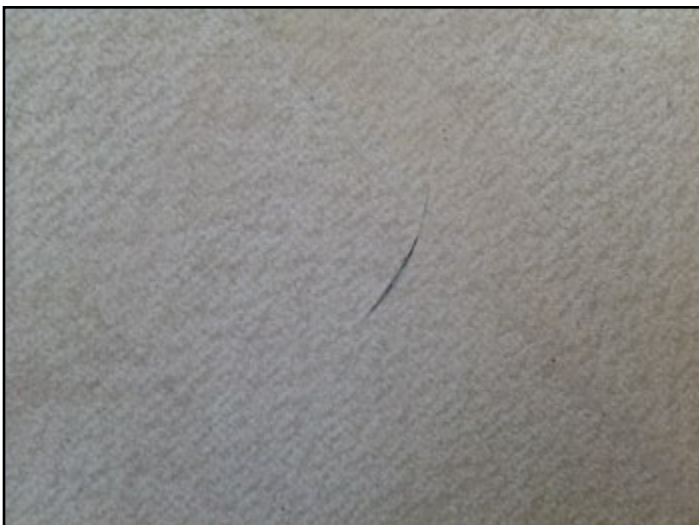
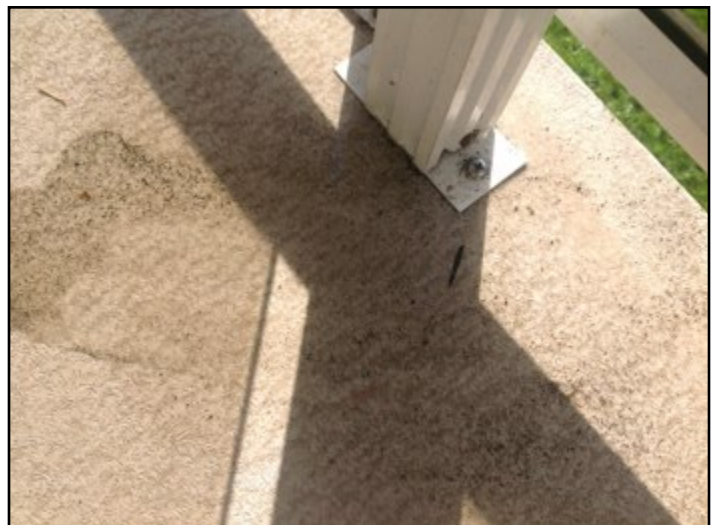
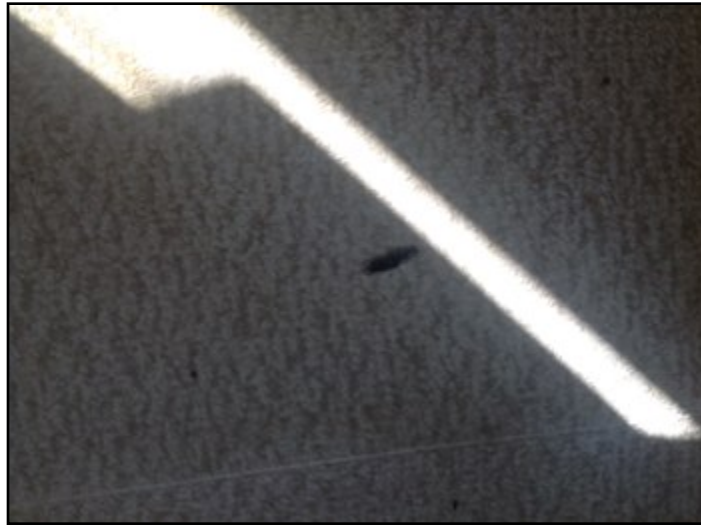
10. Condition: • [Damage](#)

Implication(s): Weakened structure | Chance of movement

19. Damage

20. Damage

21. Damage

Task: Service

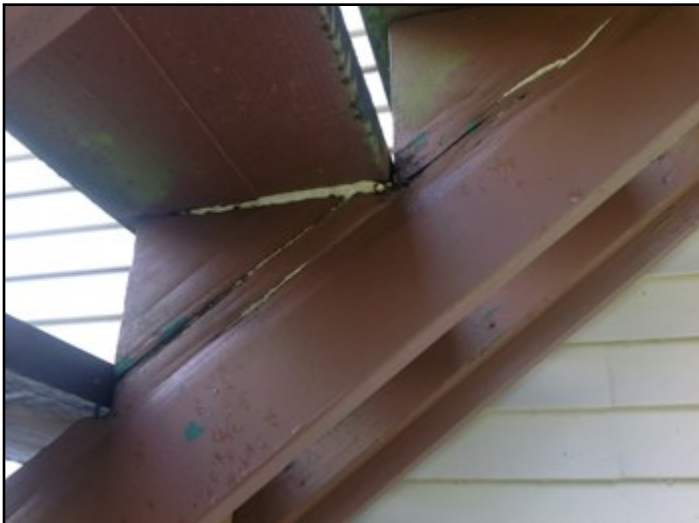
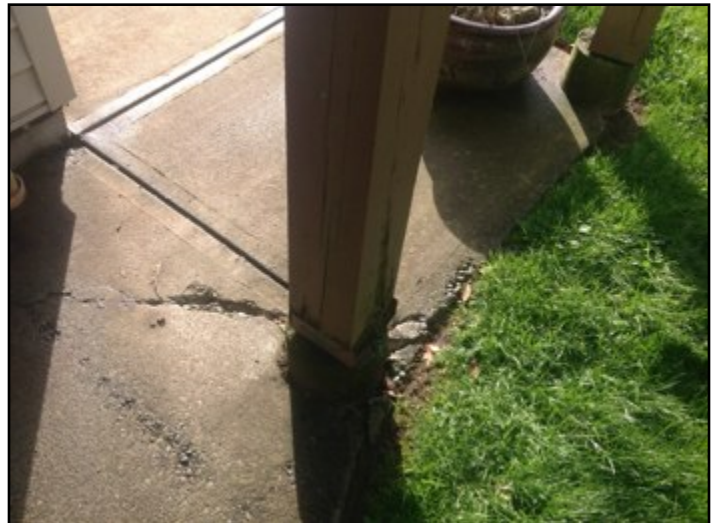
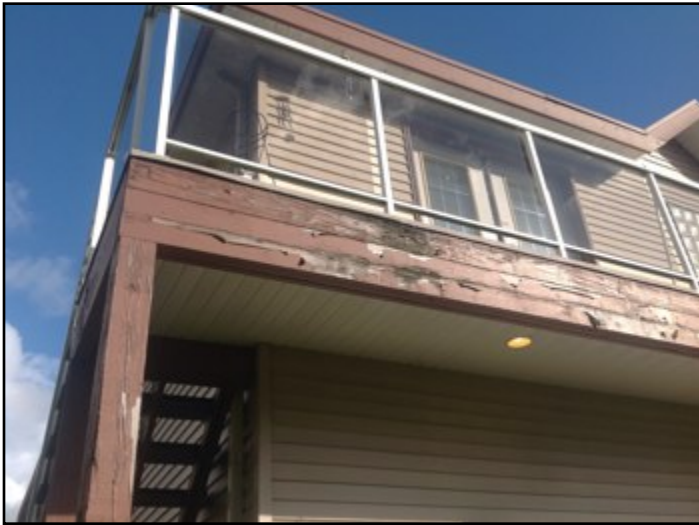
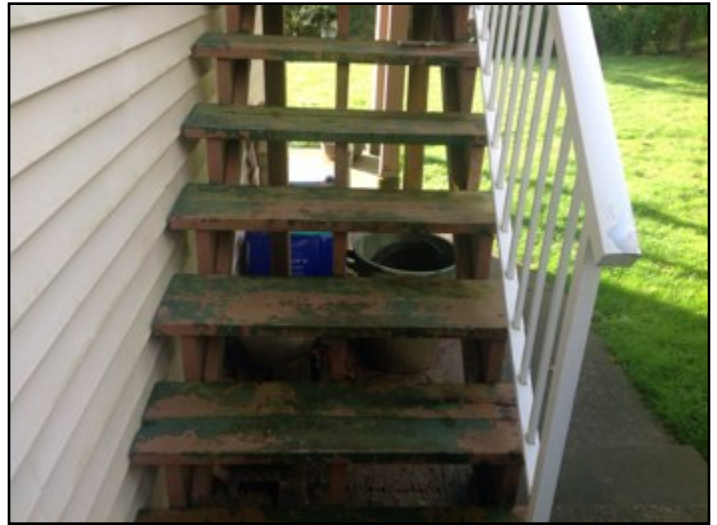
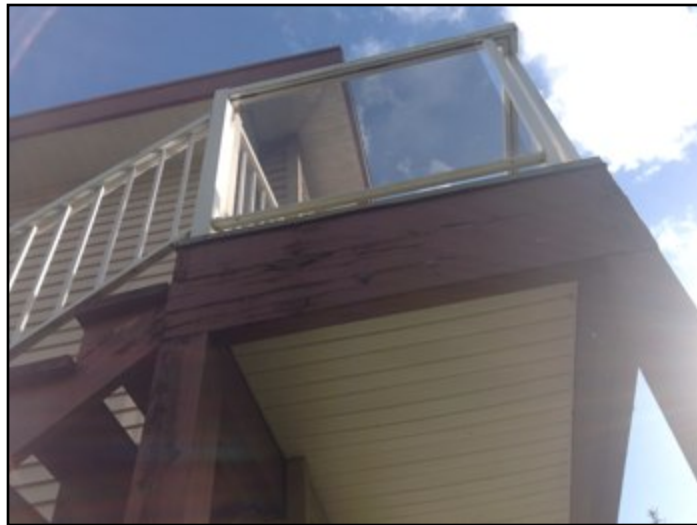
11. Condition: • [Rot or insect damage](#)

Implication(s): Weakened structure | Material deterioration

22. Rot or insect damage

23. Rot or insect damage

24. Rot or insect damage

25. Rot or insect damage

26. Rot or insect damage

Task: Repair

Time: Immediate

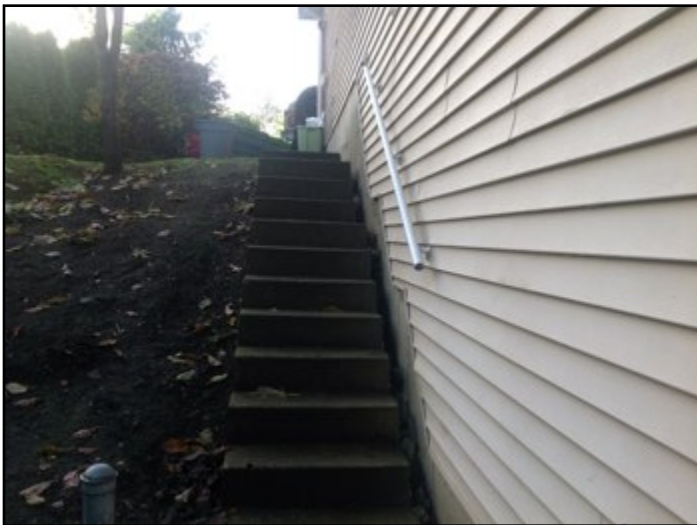
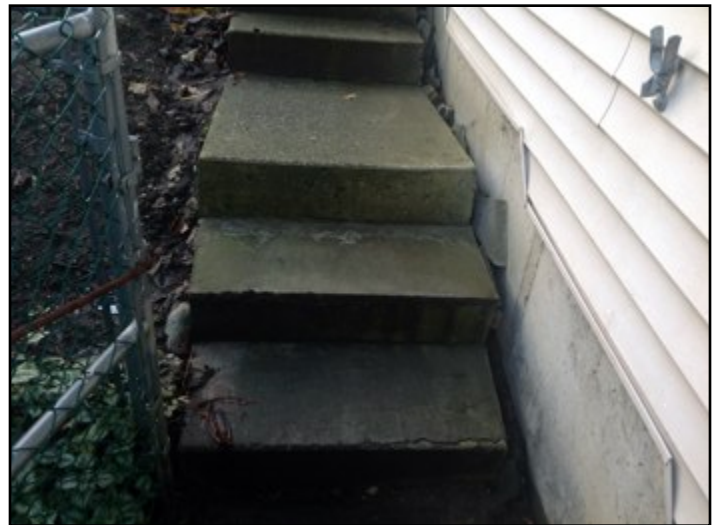
12. Condition: • [Steps or landings settling or heaving](#)

Implication(s): Weakened structure | Trip or fall hazard

27. Steps or landings settling or heaving

28. Steps or landings settling or heaving

Task: Improve

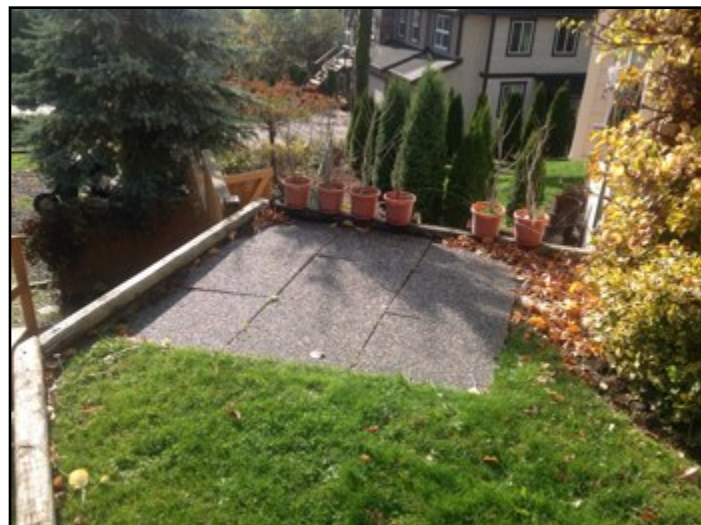
13. Condition: • [Missing](#)

Implication(s): Fall hazard

29. Missing

Task: Repair

Time: Immediate

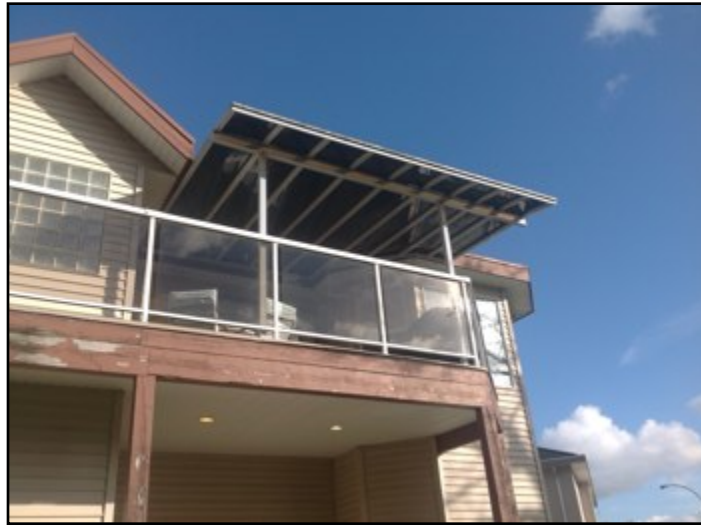
14. Condition: • Does patio cover have building permit? Consult with owner to make sure patio cover has been built to snow loads in area.

30. Does patio cover have building permit?...

Task: Further evaluation

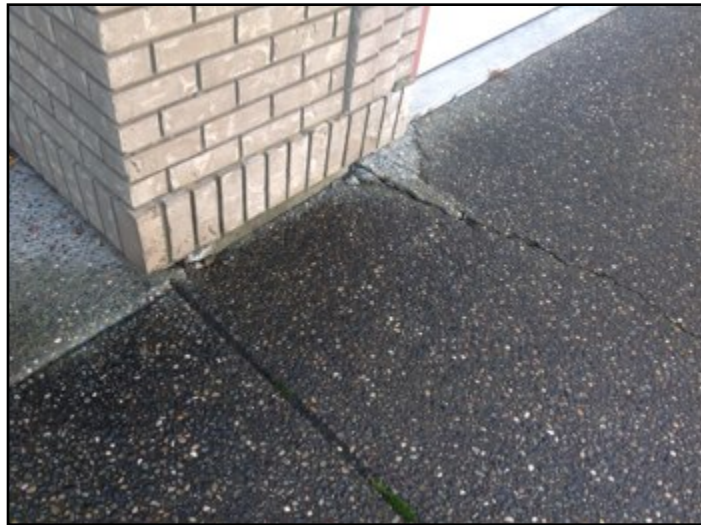
15. Condition: • [Cracked or damaged surfaces](#)

Implication(s): Trip or fall hazard

31. Cracked or damaged surfaces

Task: Service

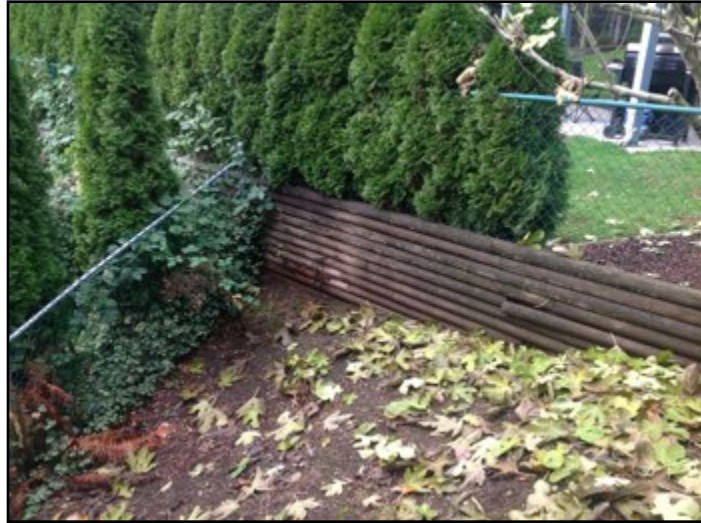
18. Condition: • [Rot](#)

Implication(s): Weakened structure | Material deterioration

32. Rot

Task: Monitor

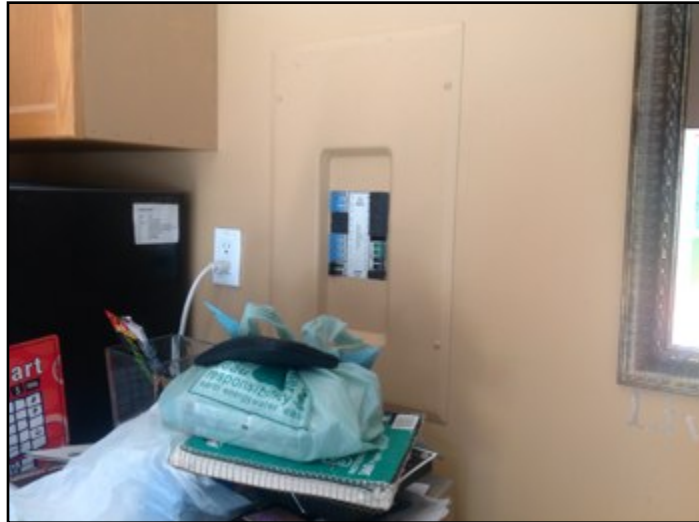
19. Condition: • Oversized panels

34. *Oversized panels*

Task: Improve

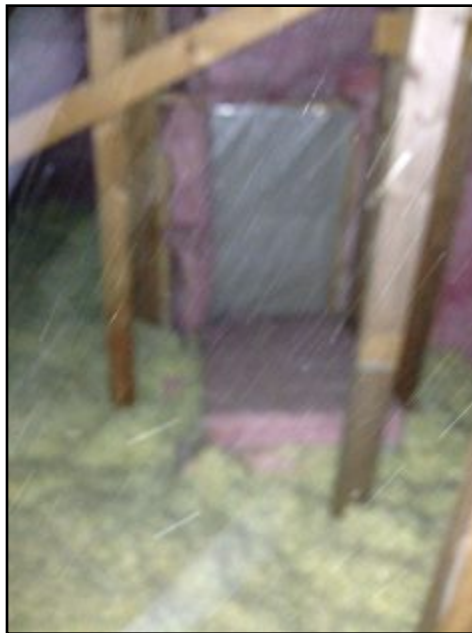
23. Condition: • [Inadequate in knee wall areas](#)

37. Inadequate in knee wall areas

Task: Improve

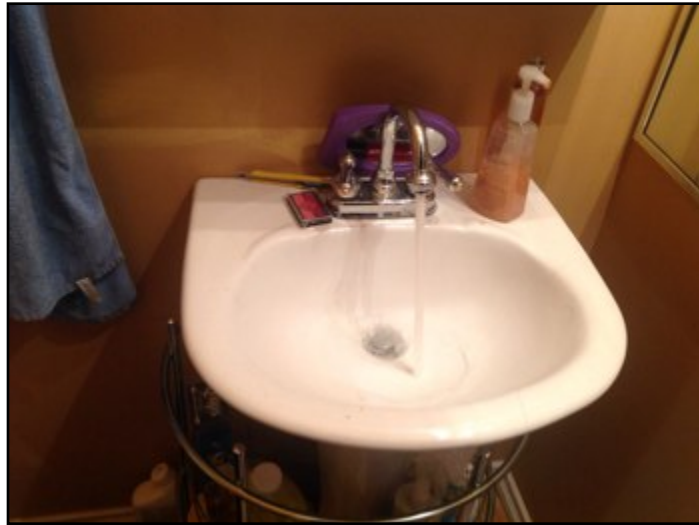
25. Condition: • [Loose](#)

Implication(s): Chance of water damage to contents, finishes and/or structure | Damage or physical injury due to falling materials | Sewage entering the house

38. Loose

Task: Service

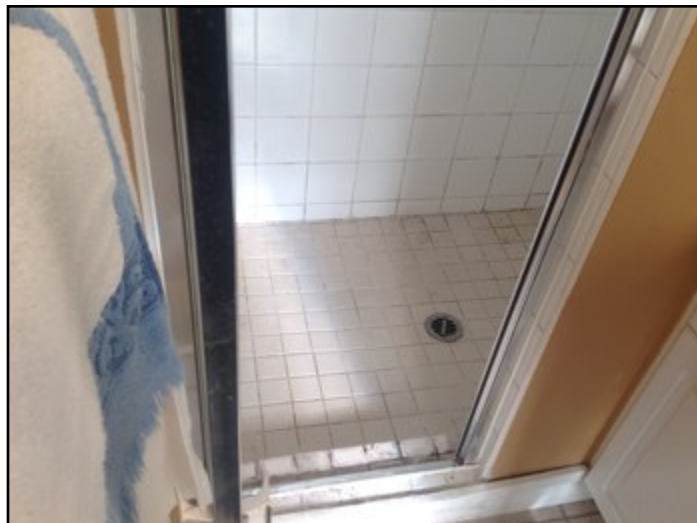
30. Condition: • [Caulking loose, missing or deteriorated](#)

Implication(s): Chance of water damage to contents, finishes and/or structure

39. Caulking loose, missing or deteriorated

Task: Repair

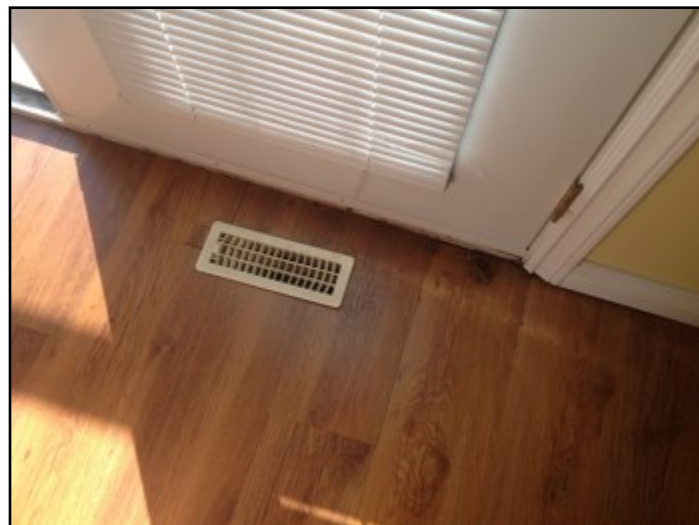
33. Condition: • [Water damage](#)

Implication(s): Cosmetic defects | Trip or fall hazard

45. Water damage

Task: Repair

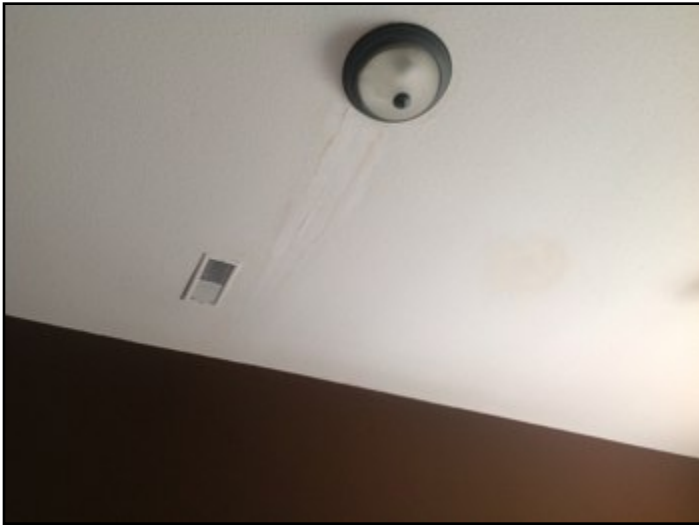
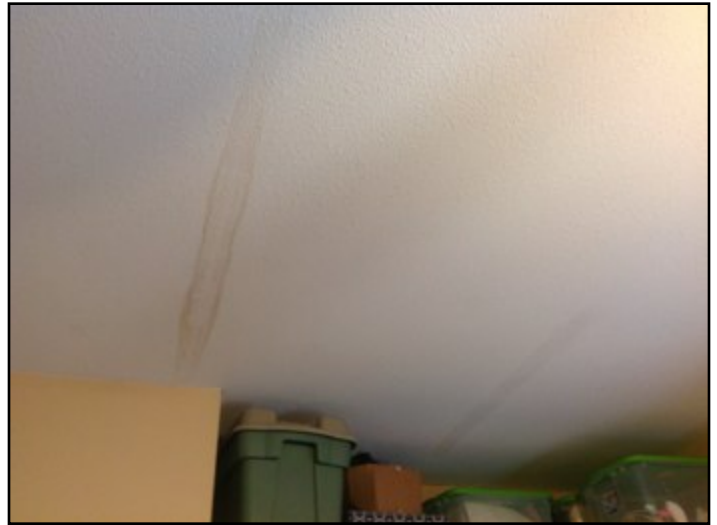
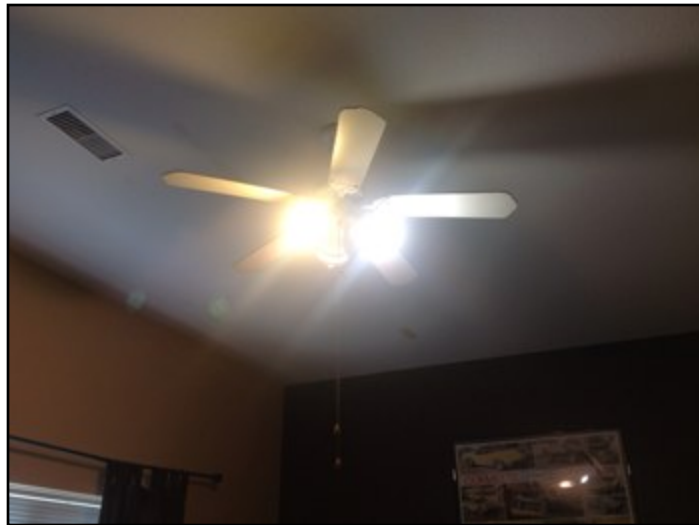
34. Condition: • [Water damage](#)

Implication(s): Cosmetic defects | Chance of movement

46. Water damage

47. Water damage

48. Water damage

Task: Repair

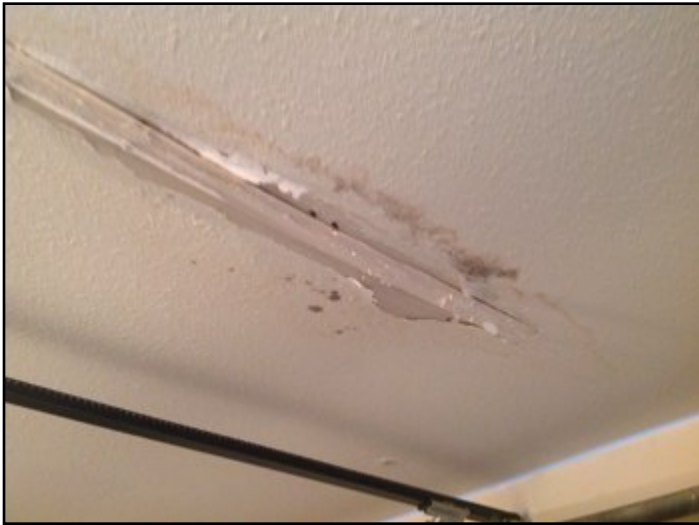
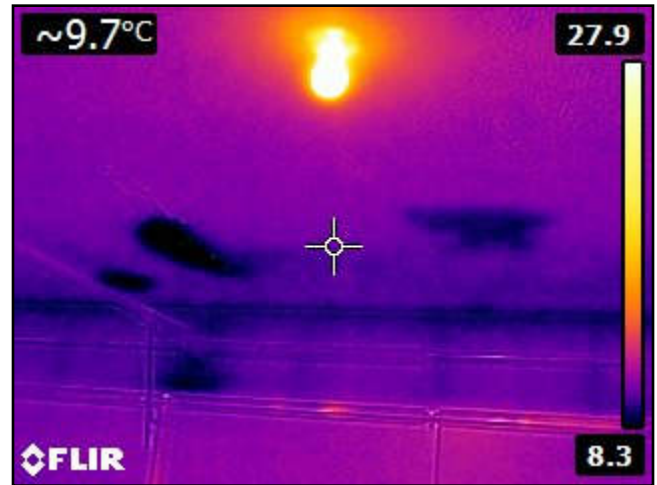
35. Condition: • [Water damage](#)

Implication(s): Cosmetic defects | Chance of movement

50. Water damage

49. Water damage

Task: Repair

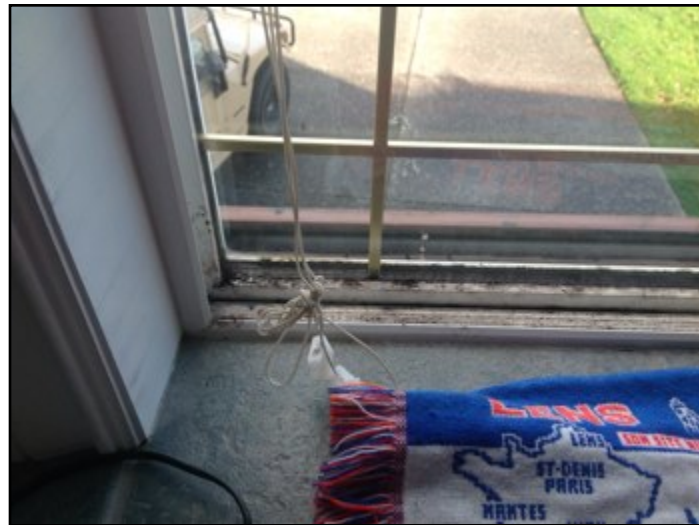
36. Condition: • Clean window tracks of mold.

51. Clean window tracks of mold.

Task: Service
