YOUR INSPECTION REPORT

1868 Knox Tr
Abbotsford, BC

Friday, November 8, 2013

RE: Report No. 1645, v.2
1868 Knox Tr
Abbotsford, BC

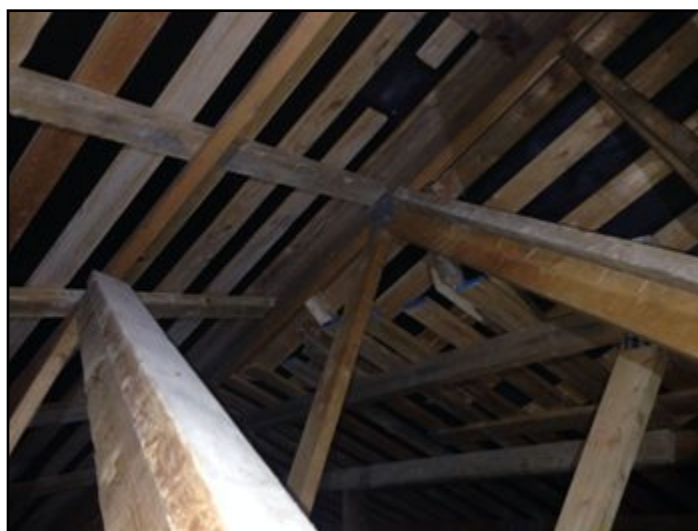
33. Plank sheathing

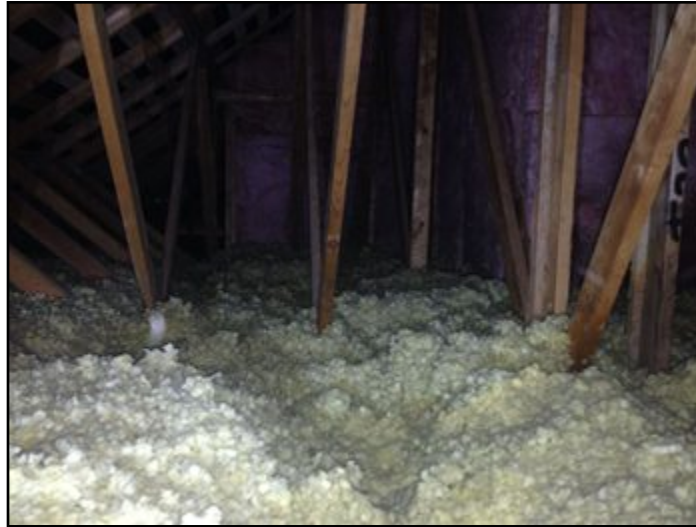
35. R-28

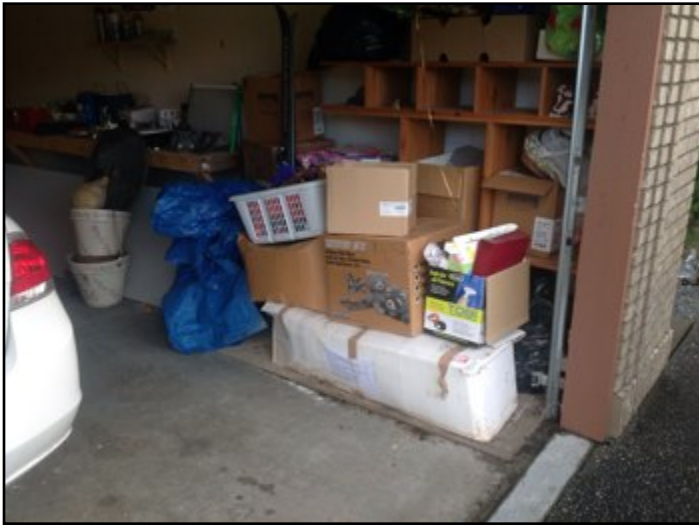
40. Storage/furnishings

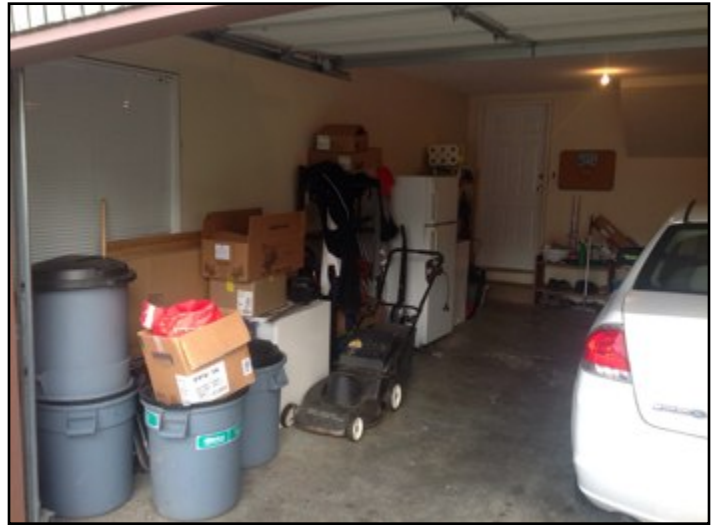
41. Storage/furnishings

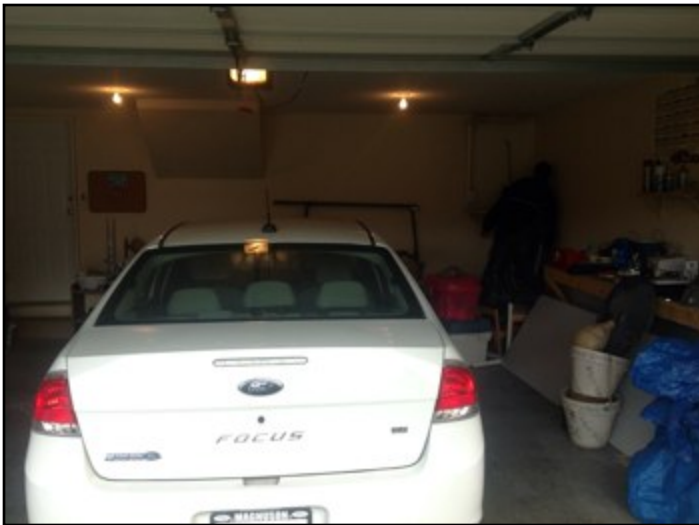
42. Storage/furnishings
